**DEPARTMENT OF TRANSPORTATION**

Contract #: 04-0120F4Cty: SF/ALA Rte: 80 PM: 13.2/13.9File #: 69.28**WELDING INSPECTION REPORT****Resident Engineer:**Siegenthaler, Peter**Address:** 333 Burma Road**City:** Oakland, CA 94607**Report No:** WIR-021130**Date Inspected:** 09-Oct-2010**Project Name:** SAS Superstructure**OSM Arrival Time:** 700**Prime Contractor:** American Bridge/Fluor Enterprises, a JV**OSM Departure Time:** 1900**Contractor:** Zhenhua Port Machinery Company, Ltd (ZPMC), Changxing Island **Location:** Shanghai, China

<b>CWI Name:</b>	Xu Xian Ping	<b>CWI Present:</b>	<b>Yes</b>	<b>No</b>
<b>Inspected CWI report:</b>	<b>Yes</b> <b>No</b> <b>N/A</b>	<b>Rod Oven in Use:</b>	<b>Yes</b> <b>No</b> <b>N/A</b>	
<b>Electrode to specification:</b>	<b>Yes</b> <b>No</b> <b>N/A</b>	<b>Weld Procedures Followed:</b>	<b>Yes</b> <b>No</b> <b>N/A</b>	
<b>Qualified Welders:</b>	<b>Yes</b> <b>No</b> <b>N/A</b>	<b>Verified Joint Fit-up:</b>	<b>Yes</b> <b>No</b> <b>N/A</b>	
<b>Approved Drawings:</b>	<b>Yes</b> <b>No</b> <b>N/A</b>	<b>Approved WPS:</b>	<b>Yes</b> <b>No</b> <b>N/A</b>	
		<b>Delayed / Cancelled:</b>	<b>Yes</b> <b>No</b> <b>N/A</b>	
<b>Bridge No:</b>	34-0006	<b>Component:</b>

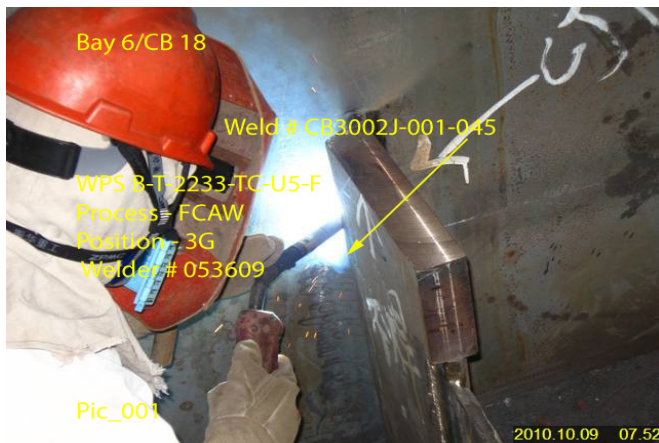
Flux Core Arc Welding (FCAW) in the 3G position of weld joint CB3002J-001-045 located on CB 18. The welder is identified as 053609. ZPMC CWI is identified as Zheng Zhi Wei. The welding variables recorded by QC appeared to comply with the WPS B-T-2233-TC-U5-F. See attached photograph Pic\_001.

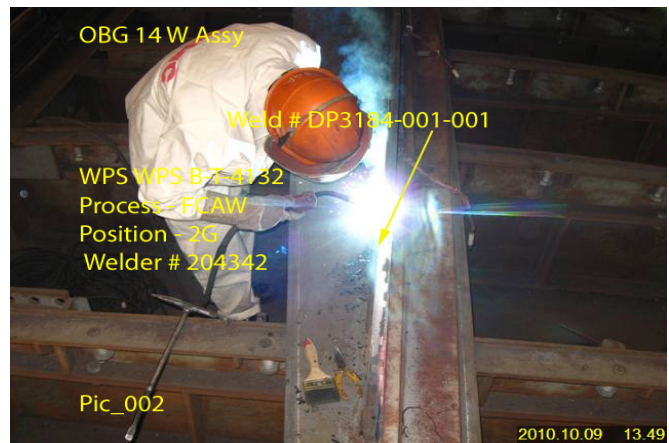
Flux Core Arc Welding (FCAW) in the 2F position of weld joint DP3184-001-001 located on Deck Panel plate DP3480A to 'I' rib. The welder is identified as 204342. ZPMC CWI is identified as Xu Hai Yang. The welding variables recorded by QC appeared to comply with the WPS B-T-4132. See attached photograph Pic\_002.
